**Flood Control Project Maintenance
Levee Inspections**

Fall 2012 Levee Maintenance Deficiency Summary Report

San Joaquin River Basin

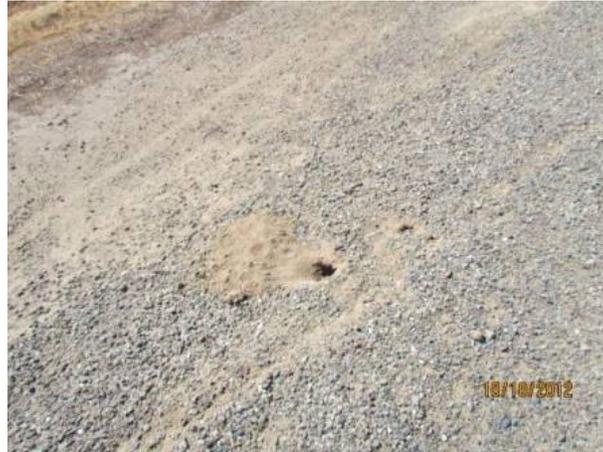
Levee Mile Report Line	74
Start Levee Mile	8.17
End Levee Mile	8.17
Location	Water Side
Category	Earthen Levee
Item	Animal Control
<p>An animal hole was found on the waterside slope of the levee looking downstream.</p>	
<p>pkazi_f_20121014_948.jpg</p>

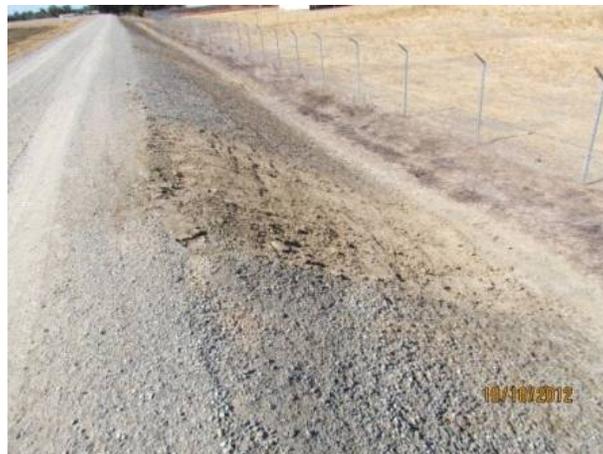
Levee Mile Report Line	76
Start Levee Mile	8.22
End Levee Mile	8.22
Location	Land Side
Category	Earthen Levee
Item	Slope Stability
<p>Slope instability issue was fixed by the LMA on the landside of the levee looking downstream.</p>	
<p>pkazi_f_20121014_949.jpg</p>

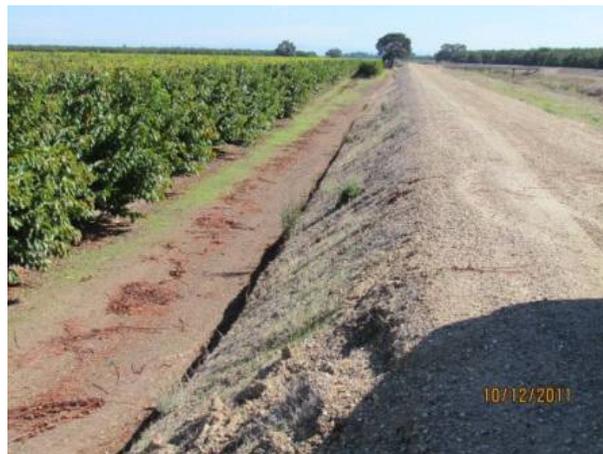
Levee Mile Report Line	77
Start Levee Mile	8.29
End Levee Mile	8.51
Location	Land Side
Category	Earthen Levee
Item	Slope Stability
<p>Farmer is cutting at the toe of landside of the levee and in addition a slope instability issue exists on the slope. The picture was taken from the crown looking upstream.</p>	
<p>pkazi_f_20120913_090.jpg</p>

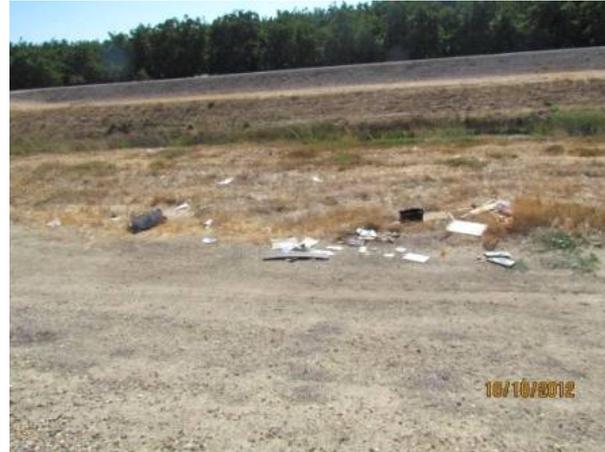
Levee Mile Report Line	78
Start Levee Mile	8.47
End Levee Mile	8.47
Location	Water Side
Category	Earthen Levee
Item	Encroachments
Debris was found on the waterside toe of the levee looking upstream.	
pkazi_f_20121014_950.jpg

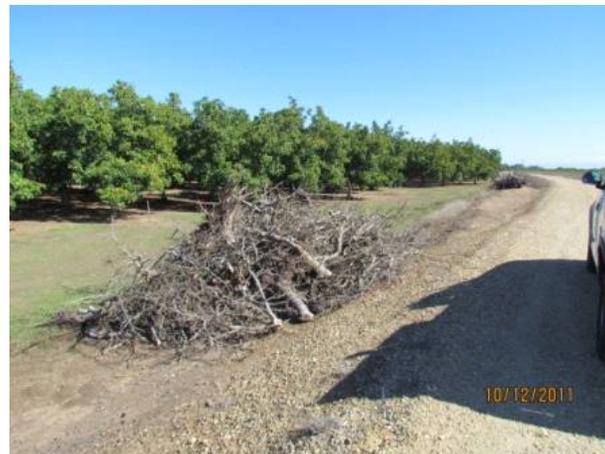
Levee Mile Report Line	79
Start Levee Mile	8.87
End Levee Mile	8.87
Location	Land Side
Category	Earthen Levee
Item	Encroachments
Pruning was found on the landside of the levee looking upstream.	
pkazi_f_20120913_046.jpg

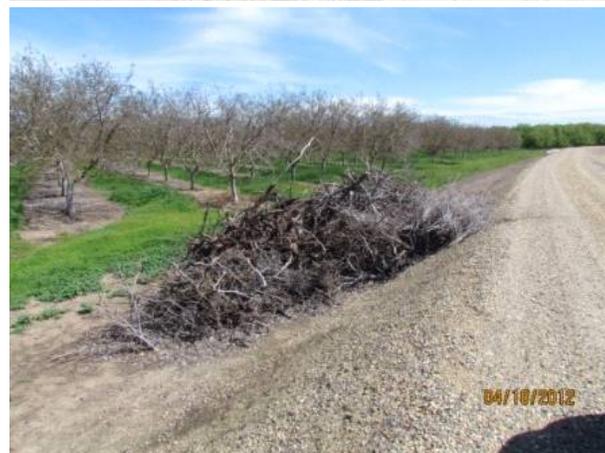
Levee Mile Report Line	80
Start Levee Mile	9.06
End Levee Mile	9.06
Location	Land Side
Category	Earthen Levee
Item	Encroachments
Pruning was found on the landside of the levee looking upstream.	
pkazi_f_20120913_101.jpg

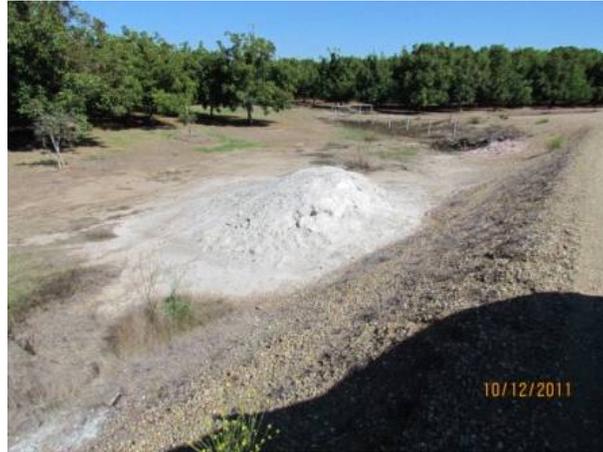
Levee Mile Report Line	81
Start Levee Mile	9.15
End Levee Mile	9.15
Location	Land Side
Category	Earthen Levee
Item	Encroachments
Ash pile was found on the landside of the levee looking upstream.	
pkazi_f_20120913_044.jpg

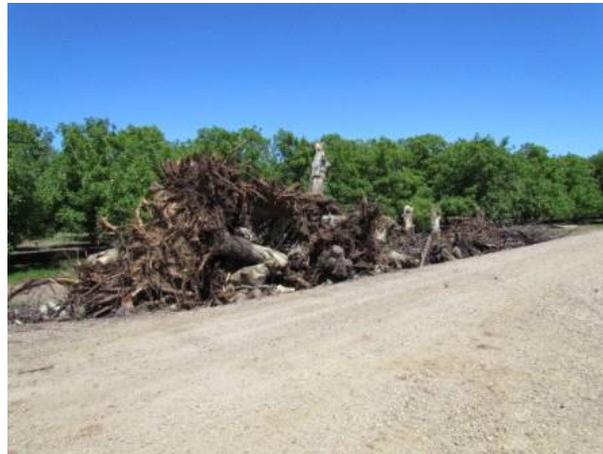
Levee Mile Report Line	82
Start Levee Mile	9.18
End Levee Mile	9.18
Location	Land Side
Category	Earthen Levee
Item	Encroachments
Burn piles on the landside of the levee. The picture was taken from the crown of the levee looking upstream.	
pkazi_f_20120913_047.jpg

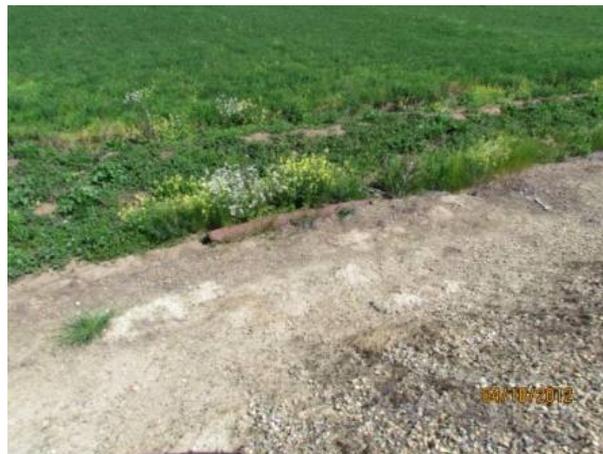
Levee Mile Report Line	84
Start Levee Mile	9.42
End Levee Mile	9.42
Location	Land Side
Category	Earthen Levee
Item	Encroachments
An abandoned pipe was found on the landside toe of the levee looking upstream.	
pkazi_f_20120913_058.jpg

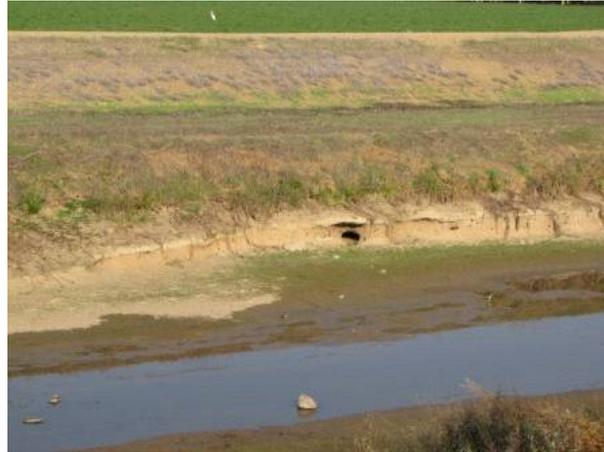
Levee Mile Report Line	85
Start Levee Mile	9.65
End Levee Mile	9.65
Location	Water Side
Category	Earthen Levee
Item	Animal Control
View of a large hole and several smaller holes from across the channel.	
pkazi_f_20120913_071.jpg

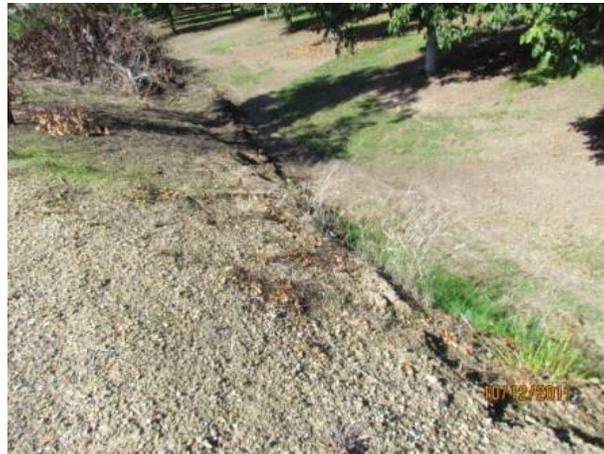
Levee Mile Report Line	87
Start Levee Mile	9.89
End Levee Mile	9.89
Location	Land Side
Category	Earthen Levee
Item	Slope Stability
Slope instability was found on the landside of the levee looking downstream.	
pkazi_f_20120913_091.jpg

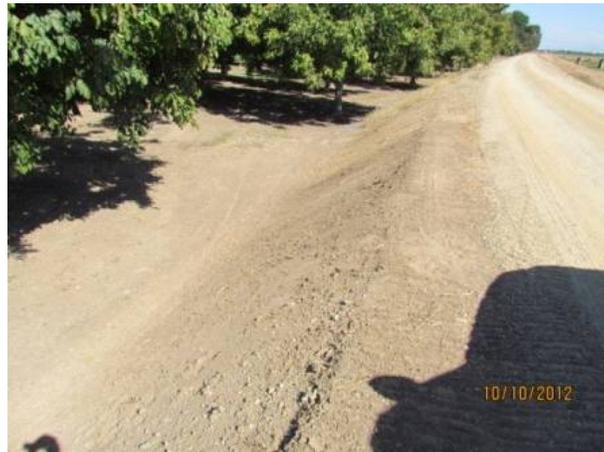
Levee Mile Report Line	89
Start Levee Mile	9.95
End Levee Mile	9.95
Location	Land Side
Category	Earthen Levee
Item	Erosion / Bank Caving
Erosion issue was fixed by the LMA on the landside of the levee looking upstream.	
pkazi_f_20121014_951.jpg

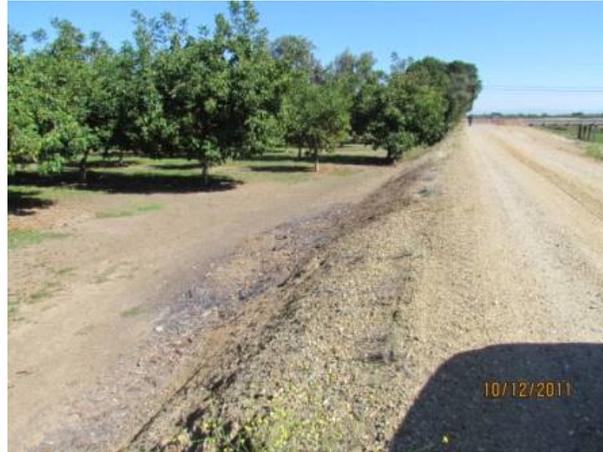
Levee Mile Report Line	90
Start Levee Mile	10.05
End Levee Mile	10.05
Location	Land Side
Category	Earthen Levee
Item	Slope Stability
Slope instability was found on the landside of the levee looking upstream.	
pkazi_f_20120913_092.jpg

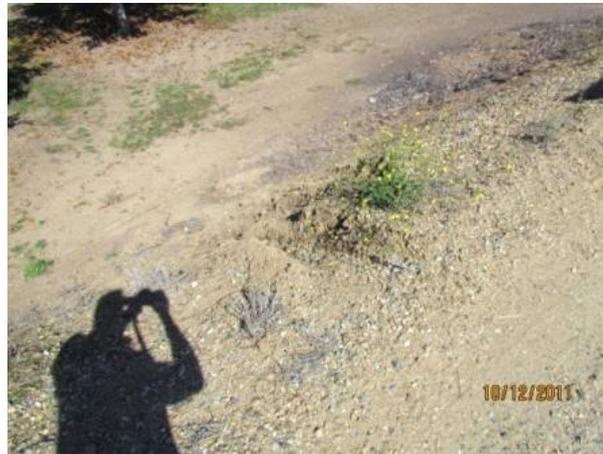
Levee Mile Report Line	90
Start Levee Mile	10.05
End Levee Mile	10.05
Location	Land Side
Category	Earthen Levee
Item	Slope Stability
Slope instability on the landside of the levee looking upstream.	
pkazi_f_20120913_093.jpg

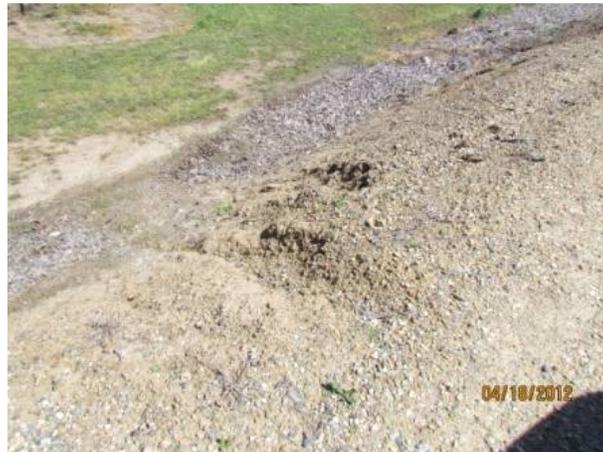
Levee Mile Report Line	90
Start Levee Mile	10.05
End Levee Mile	10.05
Location	Land Side
Category	Earthen Levee
Item	Slope Stability
Slope instability was found on the landside of the levee looking upstream. This picture was taken during spring 2012 inspection.	
pkazi_f_20120913_094.jpg

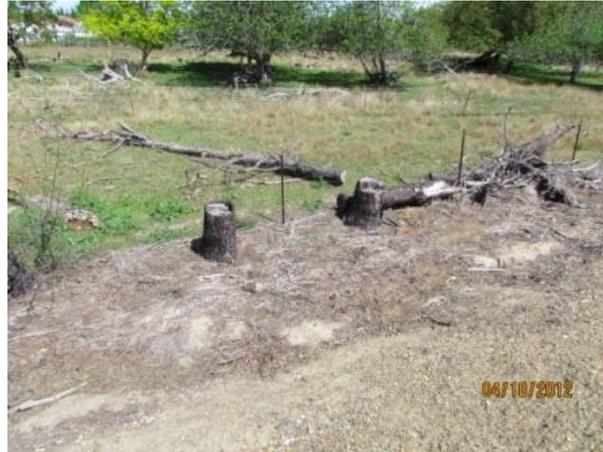
Levee Mile Report Line	92
Start Levee Mile	10.23
End Levee Mile	10.23
Location	Land Side
Category	Earthen Levee
Item	Trim / Thin Trees
Tree stumps were found on the landside of the levee looking upstream.	
pkazi_f_20120913_059.jpg

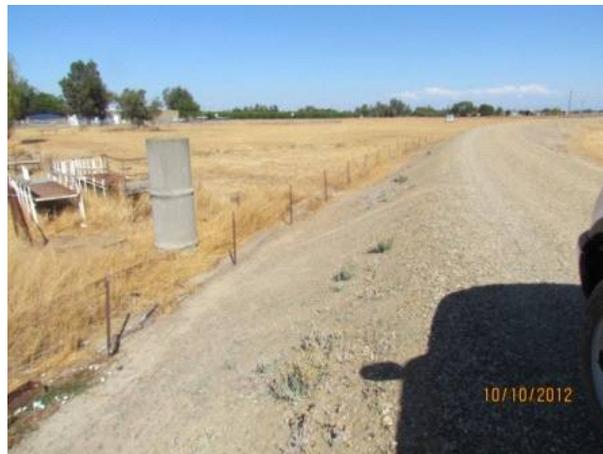
Levee Mile Report Line	96
Start Levee Mile	12.19
End Levee Mile	13.22
Location	Land Side
Category	Earthen Levee
Item	Encroachments
Fence was found on the landside toe of the levee looking upstream.	
pkazi_f_20121014_952.jpg

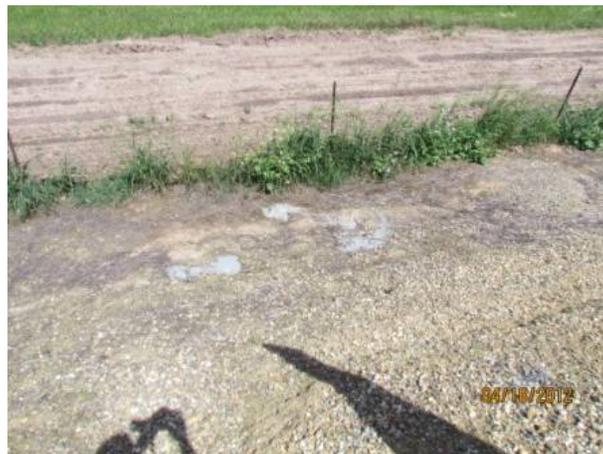
Levee Mile Report Line	97
Start Levee Mile	12.49
End Levee Mile	12.49
Location	Land Side
Category	Earthen Levee
Item	Animal Control
Animal holes were grouted by the LMA on the landside of the levee looking upstream.	
pkazi_f_20120913_062.jpg

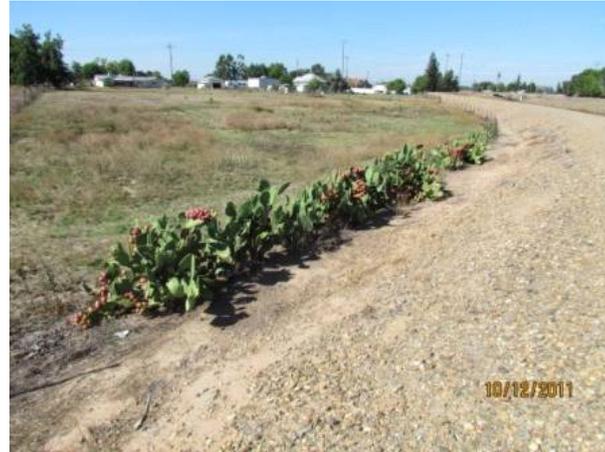
Levee Mile Report Line	98
Start Levee Mile	13.06
End Levee Mile	13.06
Location	Land Side
Category	Earthen Levee
Item	Vegetation
Cacti were found on the toe of landside of the levee looking upstream.	
pkazi_f_20120913_057.jpg

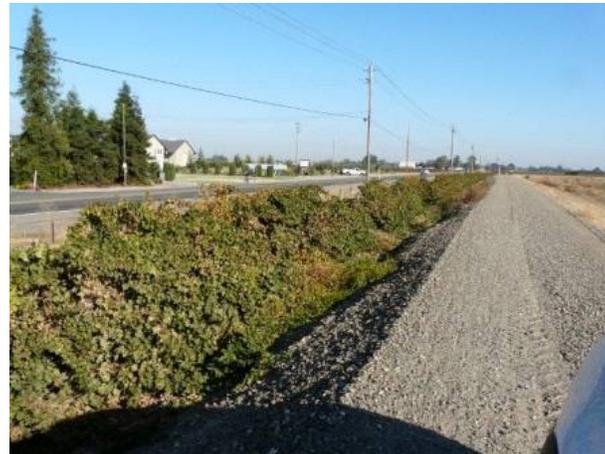
Levee Mile Report Line	99
Start Levee Mile	13.39
End Levee Mile	13.51
Location	Land Side
Category	Earthen Levee
Item	Encroachments
Grape vines within 10' from landside toe of levee from LM 13.39 to 13.51.	
pkazi_f_20120913_053.JPG

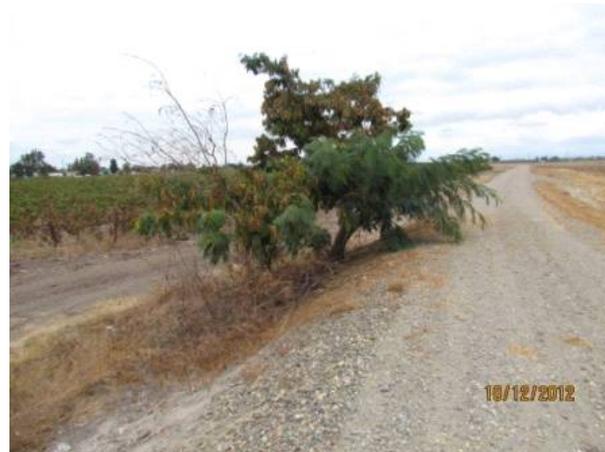
Levee Mile Report Line	101
Start Levee Mile	13.54
End Levee Mile	13.54
Location	Land Side
Category	Earthen Levee
Item	Trim / Thin Trees
Tree needs to be trimmed on the landside of the levee looking upstream.	
pkazi_f_20121014_953.jpg

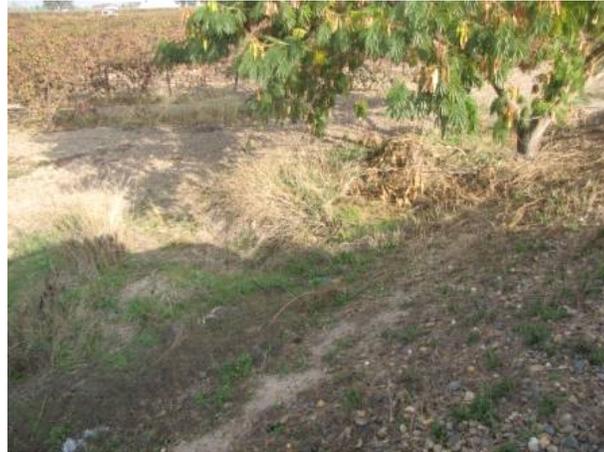
pkazi_f_20120913_068.jpg

View of a pit along the landward levee toe looking upstream.

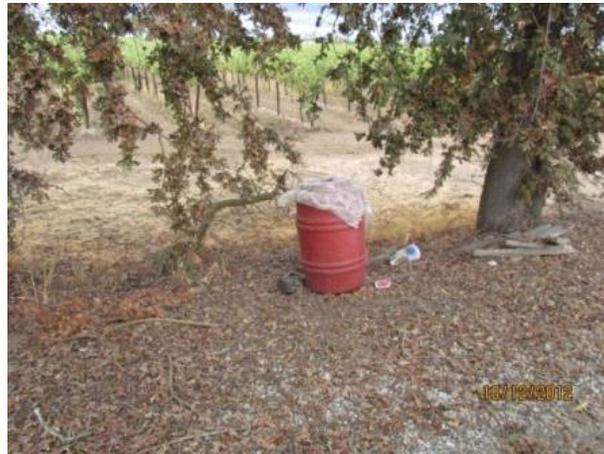
Levee Mile Report Line	104
Start Levee Mile	13.86
End Levee Mile	13.86
Location	Land Side
Category	Earthen Levee
Item	Encroachments

Debris was found on the landside of the levee looking upstream.

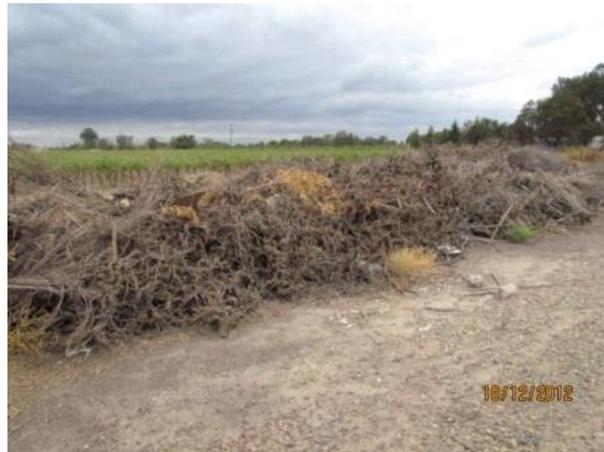
Levee Mile Report Line	105
Start Levee Mile	13.96
End Levee Mile	13.96
Location	Land Side
Category	Earthen Levee
Item	Encroachments

Prunings were found on the landside of the levee. The picture was taken from the crown looking towards the toe of the levee.

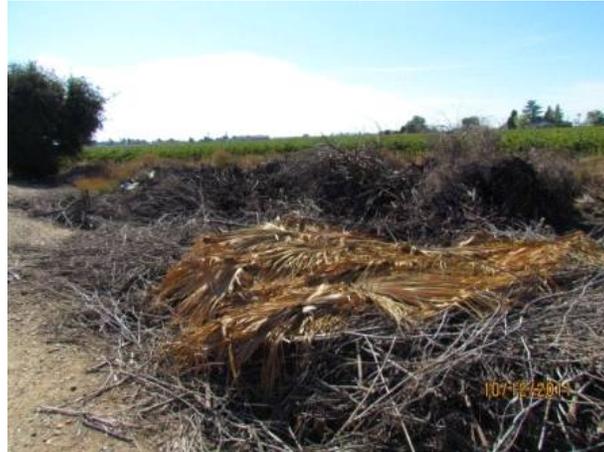
pkazi_f_20120913_098.jpg

Pruning and debris were found on the landside of the levee looking downstream.

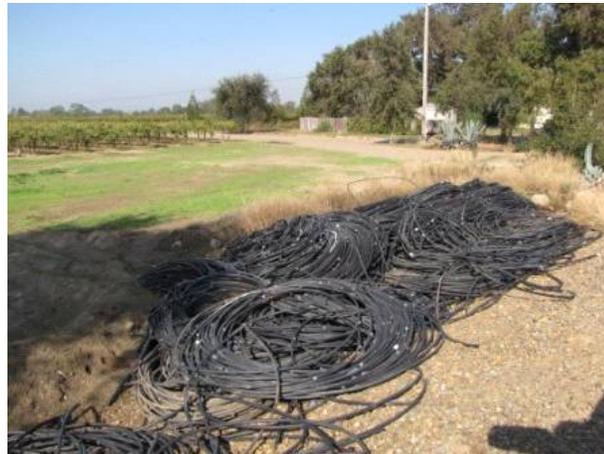
Levee Mile Report Line	107
Start Levee Mile	13.99
End Levee Mile	13.99
Location	Land Side
Category	Earthen Levee
Item	Encroachments

View of irrigation pipe on the landward slope.

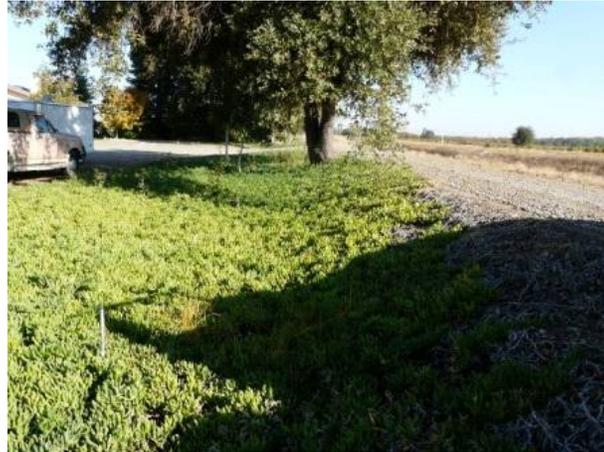
Levee Mile Report Line	110
Start Levee Mile	14.09
End Levee Mile	14.13
Location	Land Side
Category	Earthen Levee
Item	Vegetation
Landscaping on landside of levee from LM 14.09 to LM 14.13.	
pkazi_f_20120913_055.JPG

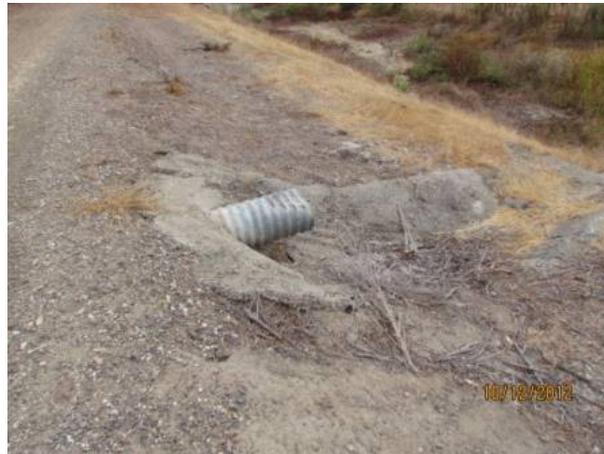
Levee Mile Report Line	112
Start Levee Mile	14.40
End Levee Mile	14.40
Location	Water Side
Category	Earthen Levee
Item	Encroachments
A pipe was found on the waterside shoulder of the levee looking upstream.	
pkazi_f_20121014_956.jpg

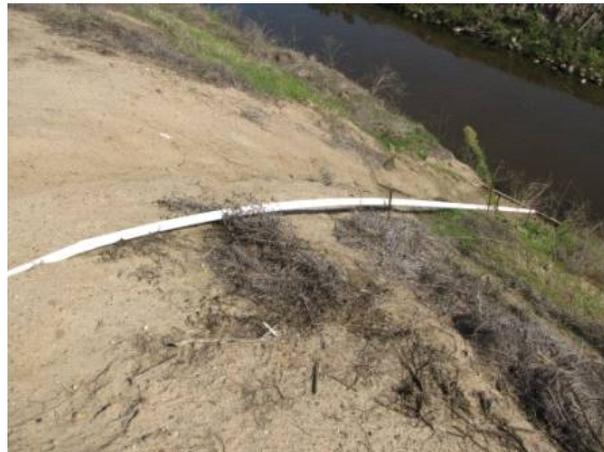
Levee Mile Report Line	113
Start Levee Mile	14.77
End Levee Mile	14.77
Location	Water Side
Category	Earthen Levee
Item	Encroachments
View of a pipe a landowner placed in the access road and waterward slope to pump water from the channel to irrigate their garden.	
pkazi_f_20120913_106.jpg

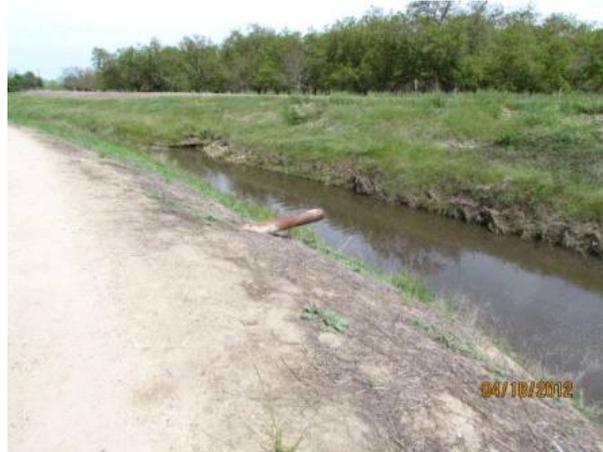
Levee Mile Report Line	114
Start Levee Mile	14.79
End Levee Mile	14.79
Location	Water Side
Category	Earthen Levee
Item	Encroachments
<p>A corroded pipe was found on the waterside of the levee looking upstream.</p>	
<p>pkazi_f_20120913_066.jpg</p>

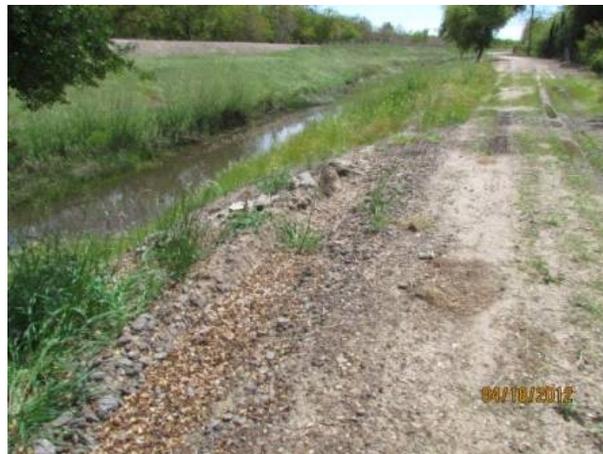
Levee Mile Report Line	116
Start Levee Mile	14.89
End Levee Mile	14.89
Location	Crown
Category	Earthen Levee
Item	Crown Surface / Depressions / Rutting
<p>Crown depression was found on the waterside shoulder of the levee looking downstream.</p>	
<p>pkazi_f_20120913_067.jpg</p>

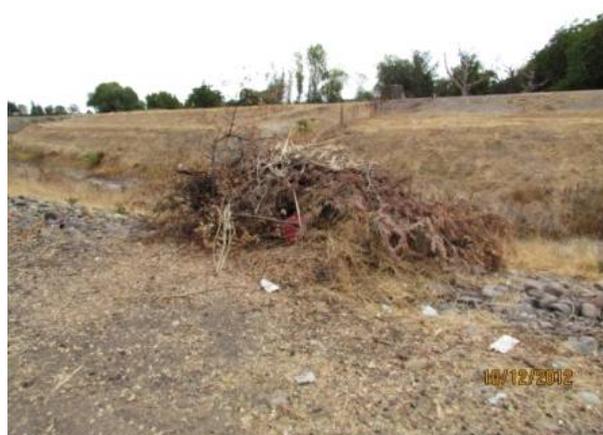
Levee Mile Report Line	117
Start Levee Mile	14.90
End Levee Mile	14.90
Location	Water Side
Category	Earthen Levee
Item	Encroachments
<p>Pruning was found on the waterside of the levee looking upstream.</p>	
<p>pkazi_f_20121014_957.jpg</p>

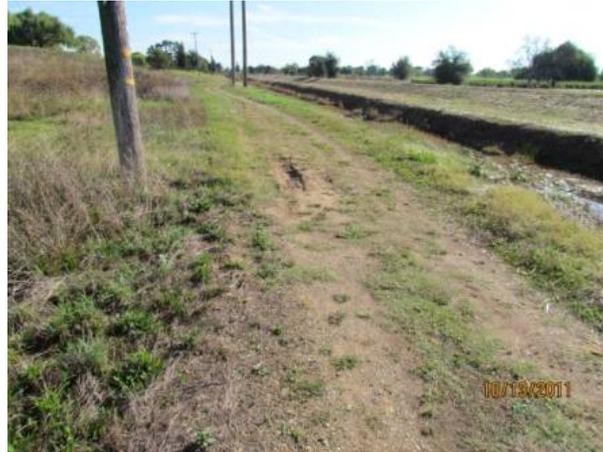
Levee Mile Report Line	119
Start Levee Mile	15.16
End Levee Mile	15.16
Location	Crown
Category	Earthen Levee
Item	Crown Surface / Depressions / Rutting
Depression was found on the crown of the levee looking upstream.	
pkazi_f_20120913_099.jpg

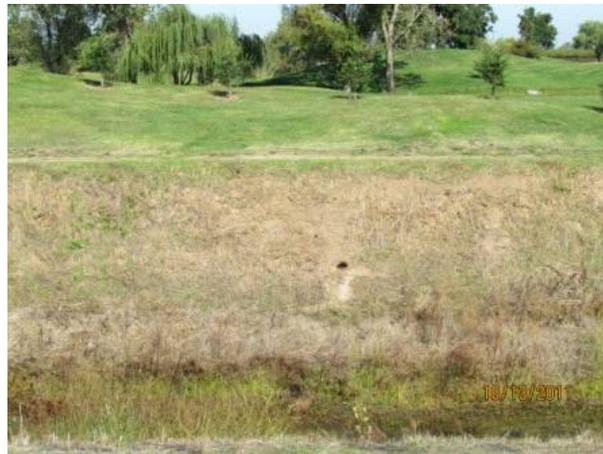
Levee Mile Report Line	120
Start Levee Mile	15.32
End Levee Mile	15.32
Location	Water Side
Category	Earthen Levee
Item	Animal Control
Rodent hole was located on right bank of Bear Creek on the waterside of the levee, levee mile 14.96. The picture was taken from crown looking towards the right bank of Bear Creek.	
pkazi_f_20120913_156.jpg

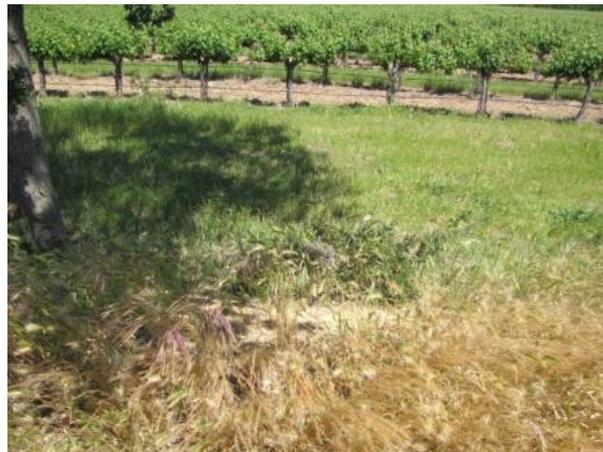
Levee Mile Report Line	121
Start Levee Mile	15.72
End Levee Mile	15.72
Location	Land Side
Category	Earthen Levee
Item	Trim / Thin Trees
View of a stump in the landward slope.	
pkazi_f_20120913_063.jpg

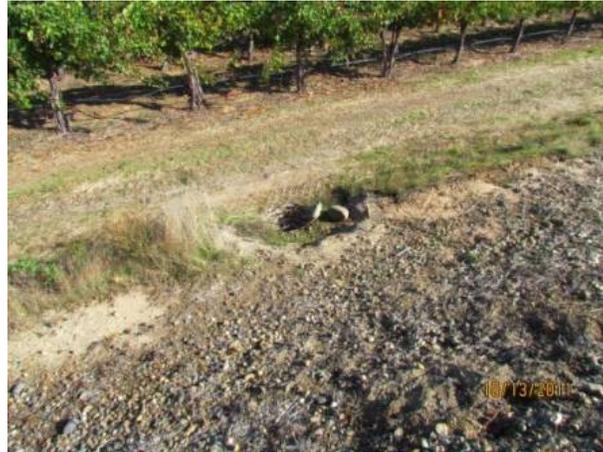
Levee Mile Report Line	122
Start Levee Mile	15.77
End Levee Mile	15.77
Location	Land Side
Category	Earthen Levee
Item	Encroachments
<p>Drain was found at the toe of landside of the levee. The picture was taken from the crown looking towards the toe.</p>	
<p>pkazi_f_20120913_100.jpg</p>

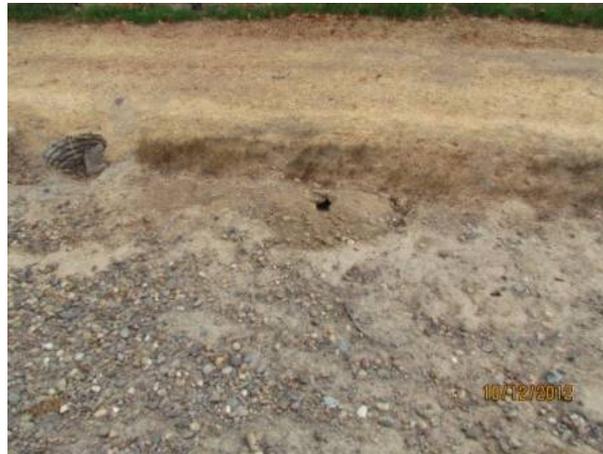
Levee Mile Report Line	123
Start Levee Mile	15.78
End Levee Mile	15.78
Location	Land Side
Category	Earthen Levee
Item	Animal Control
<p>An animal hole was found on the landside of the levee. The picture was taken from the crown looking towards the toe of the levee.</p>	
<p>pkazi_f_20121014_958.jpg</p>

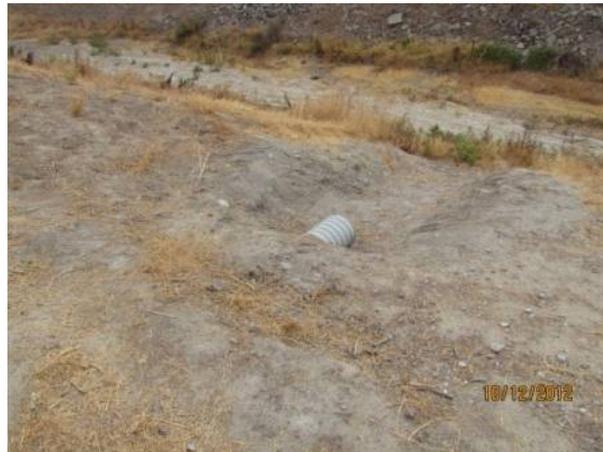
Levee Mile Report Line	125
Start Levee Mile	16.07
End Levee Mile	16.07
Location	Land Side
Category	Earthen Levee
Item	Encroachments
<p>A pipe was found on the waterside slope of the levee looking upstream.</p>	
<p>pkazi_f_20121014_959.jpg</p>

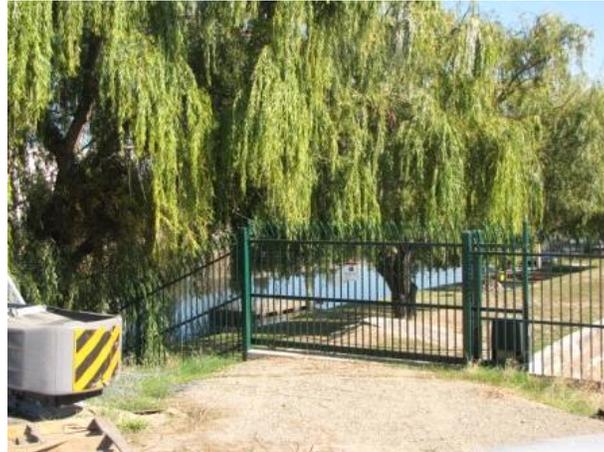
Levee Mile Report Line	1
Start Levee Mile	0.78
End Levee Mile	0.78
Location	Crown
Category	Earthen Levee
Item	Encroachments
View of a open fence and gate across the crown at the current start of the unit looking upstream. Limited access has been provided.	
pkazi_f_20120913_183.jpg

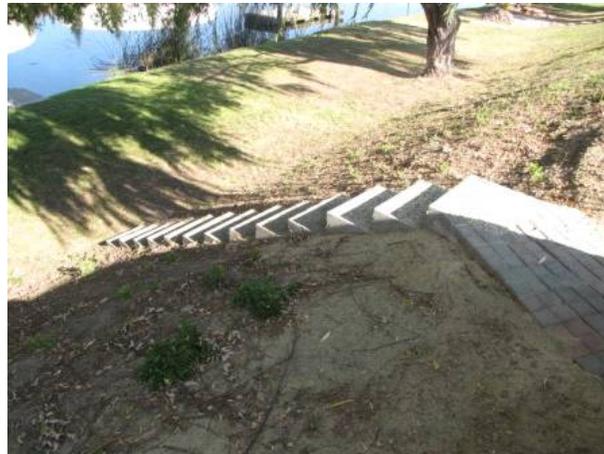
Levee Mile Report Line	2
Start Levee Mile	0.78
End Levee Mile	0.78
Location	Water Side
Category	Earthen Levee
Item	Encroachments
View of steps on the waterward slope of the levee looking upstream.	
pkazi_f_20120913_184.jpg

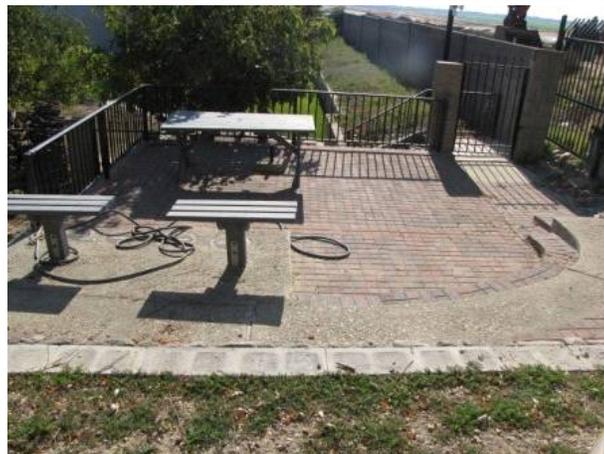
Levee Mile Report Line	3
Start Levee Mile	0.78
End Levee Mile	0.79
Location	Land Side
Category	Earthen Levee
Item	Encroachments
View of a patio with table, benches, and irrigation on the landward side of the levee.	
pkazi_f_20120913_185.jpg

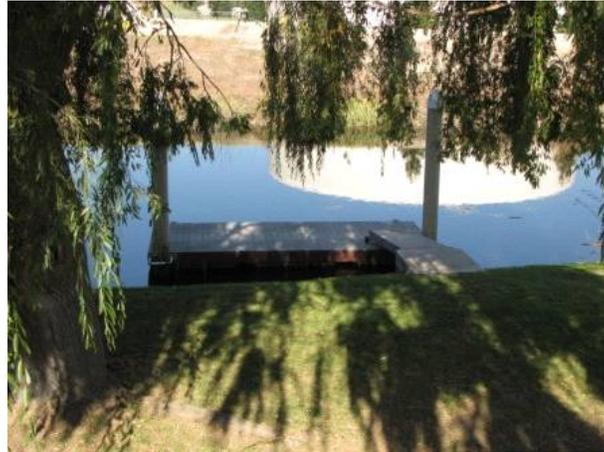
Levee Mile Report Line	4
Start Levee Mile	0.79
End Levee Mile	0.79
Location	Water Side
Category	Earthen Levee
Item	Encroachments
View of a dock off the waterward berm.	
pkazi_f_20120913_186.jpg

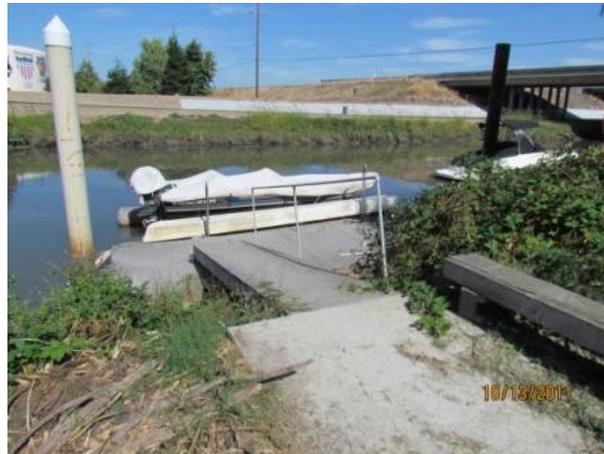
Levee Mile Report Line	4
Start Levee Mile	0.79
End Levee Mile	0.79
Location	Water Side
Category	Earthen Levee
Item	Encroachments
View of the dock at the waterside of the levee during fall 2011 inspection. The picture was taken from the crown looking upstream.	
pkazi_f_20120913_187.jpg

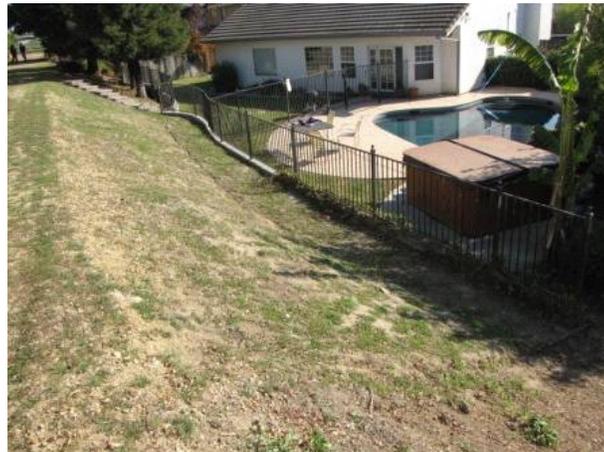
Levee Mile Report Line	5
Start Levee Mile	0.79
End Levee Mile	0.81
Location	Land Side
Category	Earthen Levee
Item	Encroachments
View of a fence on top of a retaining wall in the landward toe of the levee. Some landscaping and irrigation are also present.	
pkazi_f_20120913_188.jpg

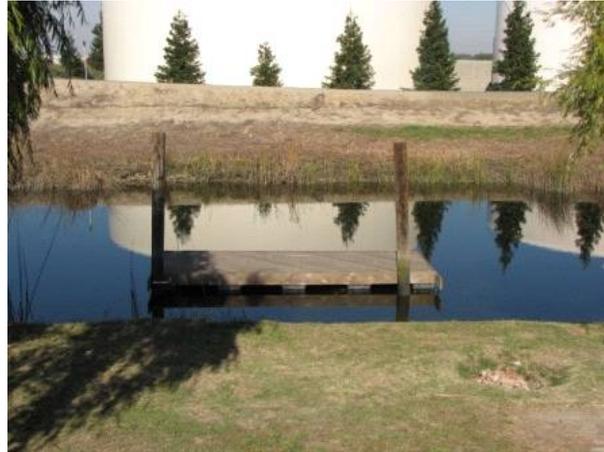
pkazi_f_20120913_189.jpg

View of a dock off the waterward side of the berm.

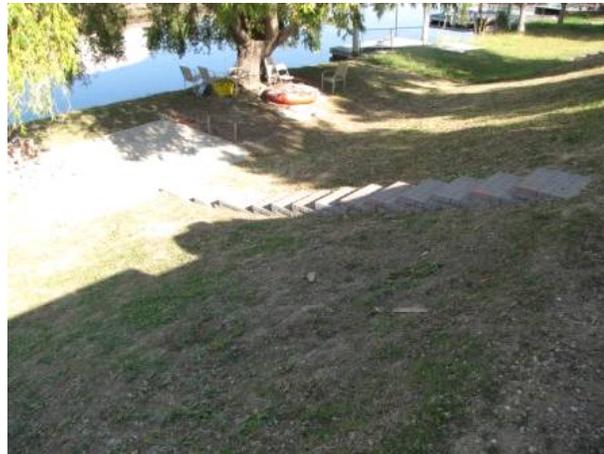
Levee Mile Report Line	7
Start Levee Mile	0.80
End Levee Mile	0.80
Location	Water Side
Category	Earthen Levee
Item	Encroachments

View of stairs and patio on the waterward slope and berm looking upstream.

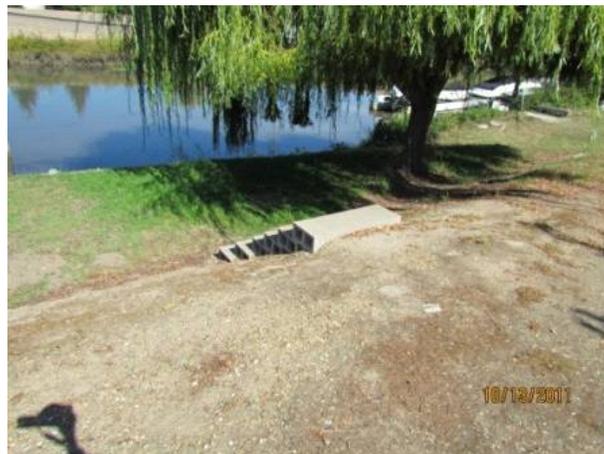
Levee Mile Report Line	7
Start Levee Mile	0.80
End Levee Mile	0.80
Location	Water Side
Category	Earthen Levee
Item	Encroachments

Stairway on the waterside slope of the levee during fall 2011 inspection.

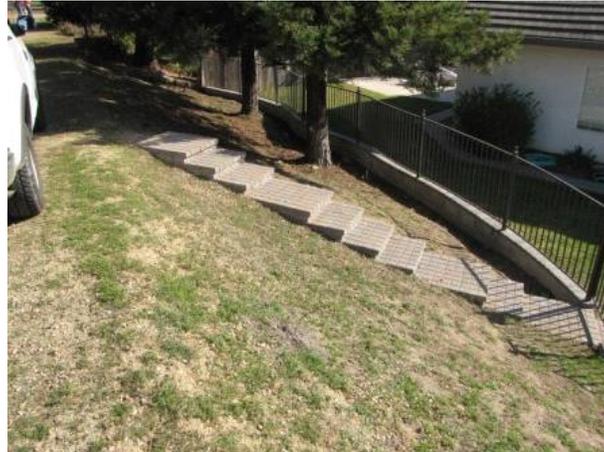
Levee Mile Report Line	8
Start Levee Mile	0.80
End Levee Mile	0.80
Location	Land Side
Category	Earthen Levee
Item	Encroachments
View of steps on the landward slope looking upstream.	
pkazi_f_20120913_200.jpg

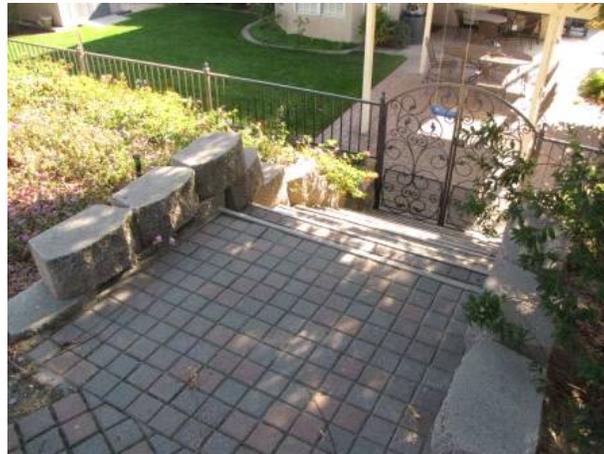
Levee Mile Report Line	9
Start Levee Mile	0.81
End Levee Mile	0.81
Location	Land Side
Category	Earthen Levee
Item	Encroachments
View of steps on the landward slope.	
pkazi_f_20120913_194.jpg

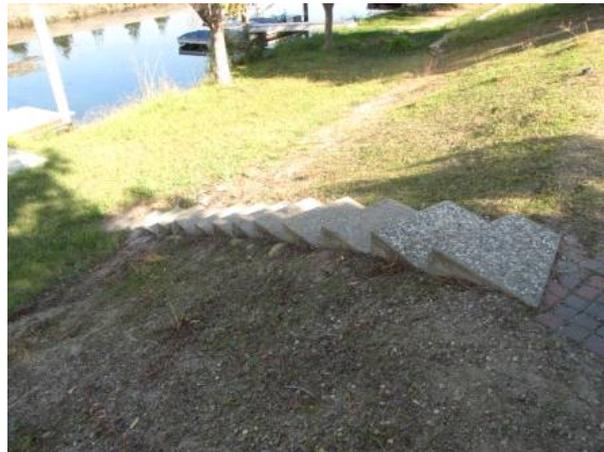
Levee Mile Report Line	10
Start Levee Mile	0.81
End Levee Mile	0.81
Location	Water Side
Category	Earthen Levee
Item	Encroachments
View of steps on the waterward slope looking upstream.	
pkazi_f_20120913_195.jpg

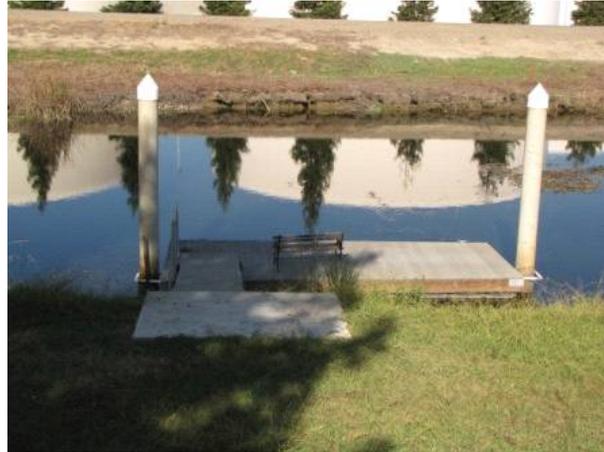
Levee Mile Report Line	11
Start Levee Mile	0.81
End Levee Mile	0.81
Location	Water Side
Category	Earthen Levee
Item	Encroachments
View of a dock on the waterward side of the berm.	
pkazi_f_20120913_196.jpg

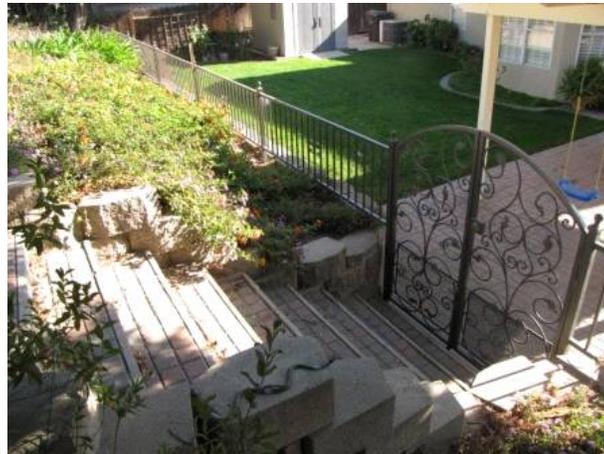
Levee Mile Report Line	12
Start Levee Mile	0.81
End Levee Mile	0.82
Location	Land Side
Category	Earthen Levee
Item	Encroachments
View of a open fence on a retaining wall in the landward toe of the levee looking upstream.	
pkazi_f_20120913_192.jpg

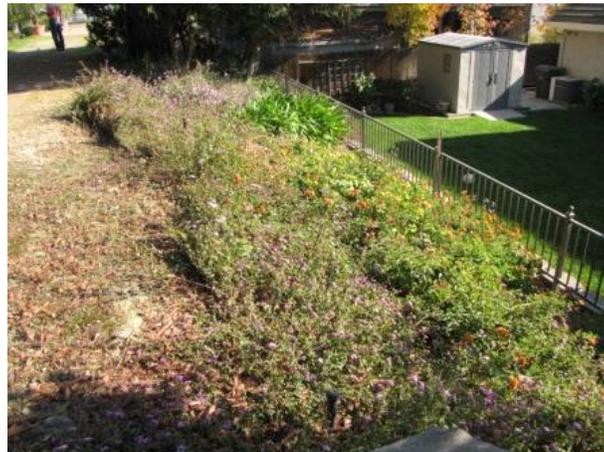
Levee Mile Report Line	13
Start Levee Mile	0.81
End Levee Mile	0.82
Location	Land Side
Category	Earthen Levee
Item	Vegetation
View of landscaping obstructing visibility and access and irrigation along the landward slope looking upstream.	
pkazi_f_20120913_193.jpg

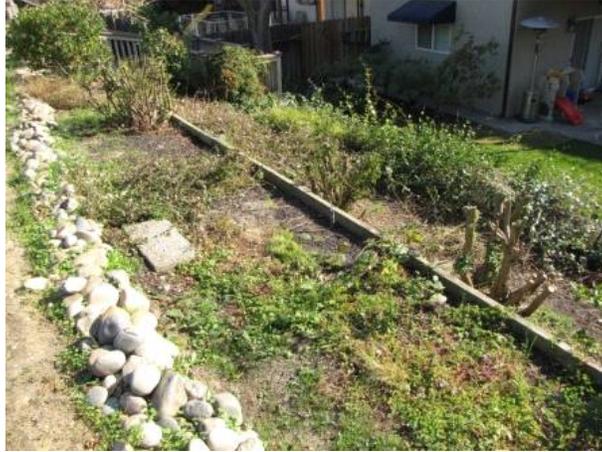
Levee Mile Report Line	15
Start Levee Mile	0.82
End Levee Mile	0.83
Location	Land Side
Category	Earthen Levee
Item	Vegetation
View of landscaping and irrigation along the landward slope looking upstream.	
pkazi_f_20120913_197.jpg

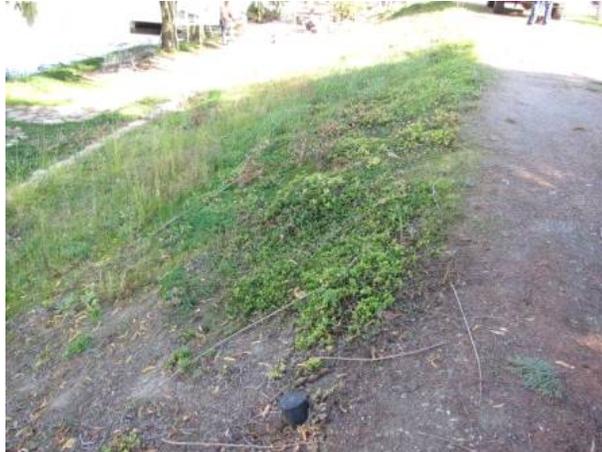
Levee Mile Report Line	16
Start Levee Mile	0.82
End Levee Mile	0.83
Location	Water Side
Category	Earthen Levee
Item	Vegetation
View of landscaping and irrigation on the waterward slope looking upstream.	
pkazi_f_20120913_198.jpg

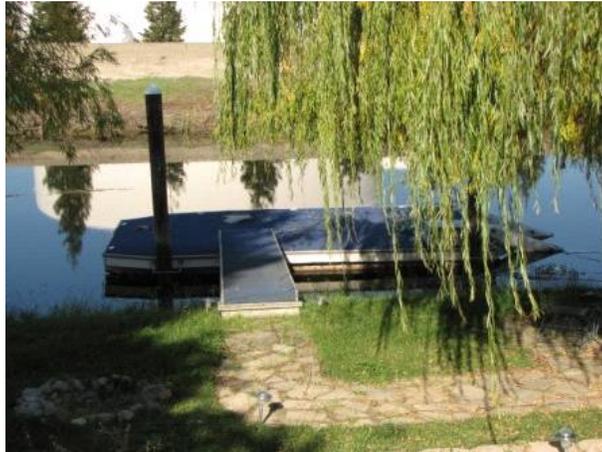
Levee Mile Report Line	17
Start Levee Mile	0.82
End Levee Mile	0.82
Location	Water Side
Category	Earthen Levee
Item	Encroachments
View of a dock and pathway on the waterward side of the berm.	
pkazi_f_20120913_199.jpg

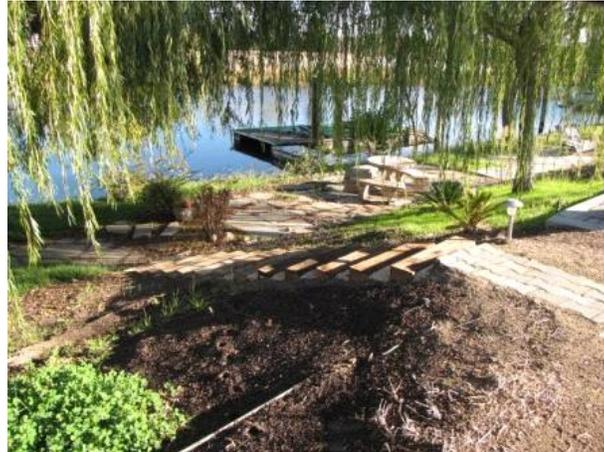
Levee Mile Report Line	18
Start Levee Mile	0.83
End Levee Mile	0.83
Location	Land Side
Category	Earthen Levee
Item	Encroachments
View of recently modified steps on the waterward slope of the levee looking upstream.	
pkazi_f_20120913_107.jpg

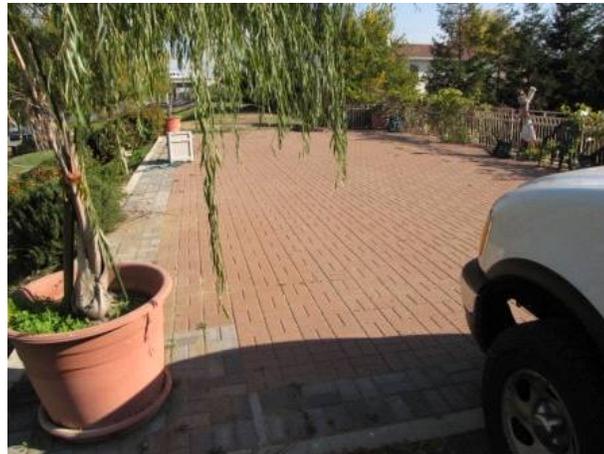
Levee Mile Report Line	19
Start Levee Mile	0.83
End Levee Mile	0.84
Location	Crown
Category	Earthen Levee
Item	Encroachments
View of pavers placed on the crown of the levee looking upstream. Potted landscaping and irrigation can also be seen.	
pkazi_f_20120913_201.jpg

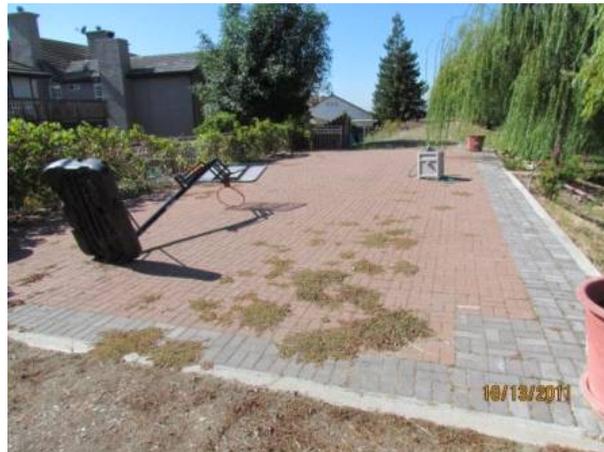
Levee Mile Report Line	19
Start Levee Mile	0.83
End Levee Mile	0.84
Location	Crown
Category	Earthen Levee
Item	Encroachments
View of pavers placed on the crown looking downstream. This picture was taken during fall 2011 inspection.	
pkazi_f_20120913_202.jpg

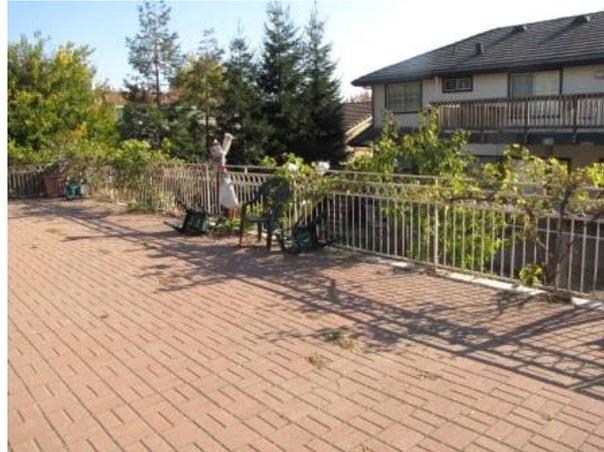
Levee Mile Report Line	20
Start Levee Mile	0.83
End Levee Mile	0.84
Location	Land Side
Category	Earthen Levee
Item	Encroachments
View of a fence on top of a large retaining wall in the landward slope looking upstream. Landscaping is growing along the fence.	
pkazi_f_20120913_203.jpg

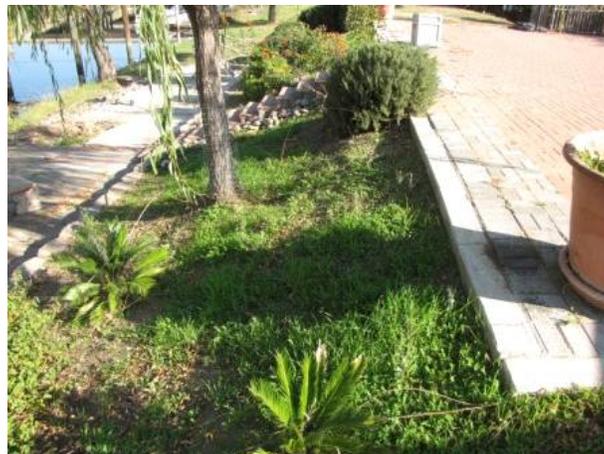
Levee Mile Report Line	21
Start Levee Mile	0.83
End Levee Mile	0.84
Location	Water Side
Category	Earthen Levee
Item	Vegetation
View of landscaping and irrigation on the waterward slope looking upstream.	
pkazi_f_20120913_205.jpg

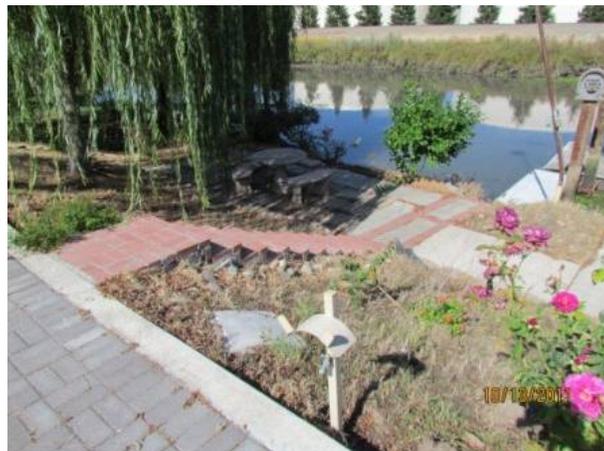
Levee Mile Report Line	21
Start Levee Mile	0.83
End Levee Mile	0.84
Location	Water Side
Category	Earthen Levee
Item	Vegetation
View of the landscaping on the waterside of the levee looking downstream. This picture was taken during fall 2011 inspection.	
pkazi_f_20120913_206.jpg

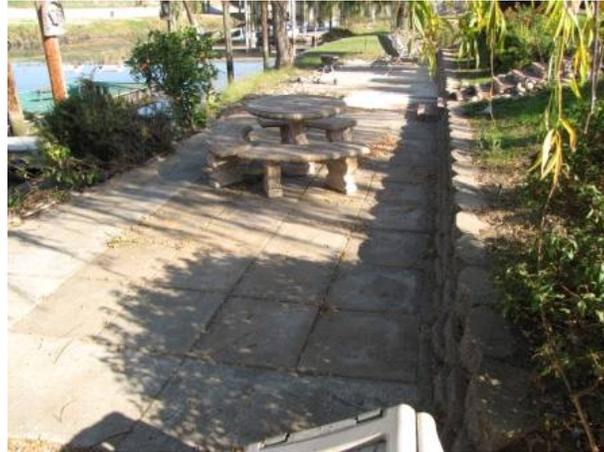
View of a retaining wall and patio with furniture in the waterward toe and berm looking upstream.

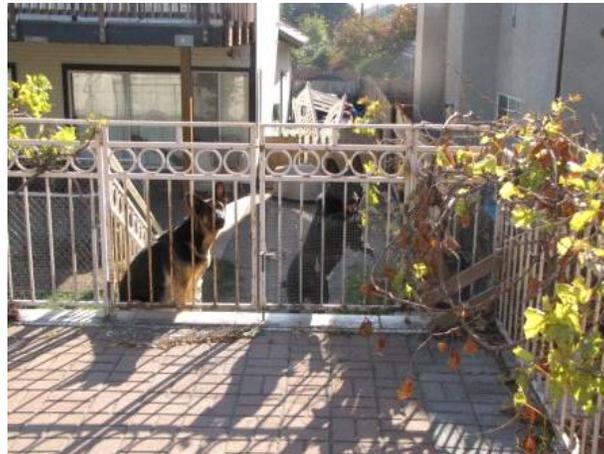
Levee Mile Report Line	23
Start Levee Mile	0.83
End Levee Mile	0.83
Location	Land Side
Category	Earthen Levee
Item	Encroachments

View of steps on the landward slope and dogs preventing a closer inspection.

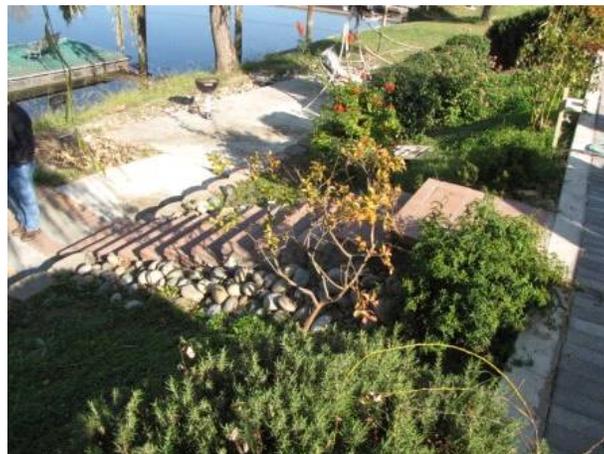
Levee Mile Report Line	24
Start Levee Mile	0.84
End Levee Mile	0.84
Location	Water Side
Category	Earthen Levee
Item	Encroachments

View of steps on the waterward slope of the levee looking upstream.

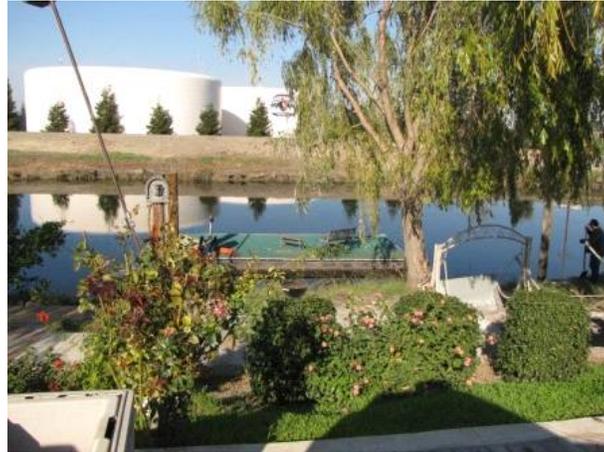
Levee Mile Report Line	25
Start Levee Mile	0.84
End Levee Mile	0.84
Location	Water Side
Category	Earthen Levee
Item	Encroachments
View of a dock on the waterward side of the berm.	
pkazi_f_20120913_209.jpg

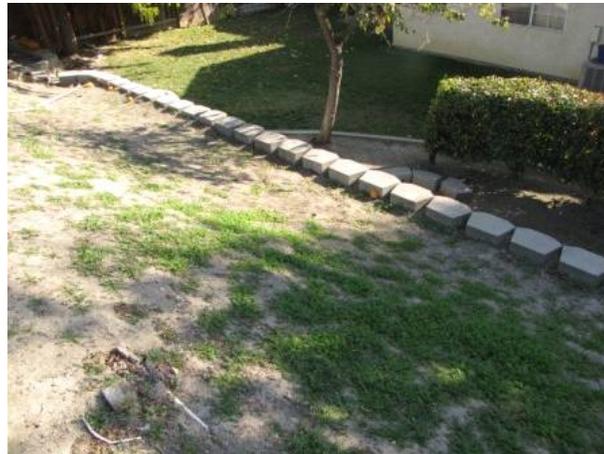
Levee Mile Report Line	26
Start Levee Mile	0.84
End Levee Mile	0.85
Location	Land Side
Category	Earthen Levee
Item	Encroachments
View of a retaining wall in the landward slope.	
pkazi_f_20120913_210.jpg
